RFP 2026-GA-01

Project Design for Asbestos Abatement

75 North Dr.
Westborough MA. 01581

ASBESTOS SURVEY

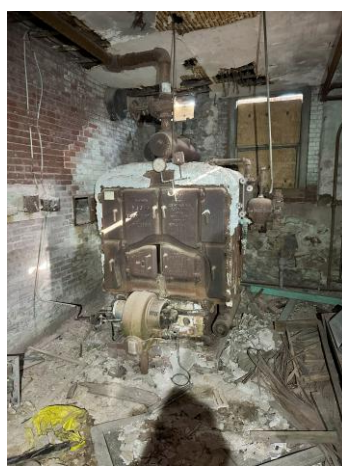
B-A5 B-A6

Sample #	Location	Description	Color	% Asbestos	Quantities
B-A4b	Basement	Joint Compound	Off White	2%	3600+/- Sheetrock & Joint collapse. is in debris from collapse
B-A5	Basement	Boiler Insulation	Gray	75%	300SF as noted in B-A6
B-A7	Basement	Window Glazing	Beige	2%	All windows as noted in B-A8
B-A6	BASEMENT	BOILER INSULATION	Gray	75%	300SF +/-
B-A8	BASEMENT	WINDOW GLAING	BEIGE	2%	All windows. 75 Units
B-A12A	STAIRWELL BETWEEN 1 ST & 2 ND FLOOR ROOM	FLOOR TILE	BROWN	5%	145SF +/-
B-A13A	STAIRWELL BETWEEN 1 ST & 2 ND FLOOR ROOM	FLOOR TILE	BROWN	5%	145SF +/-

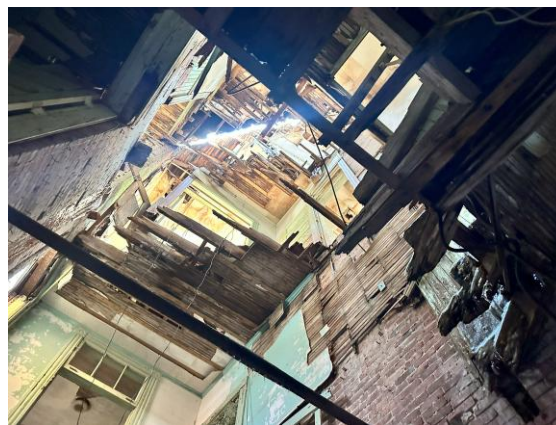
Interior of this building has 3 floors which has collapsed and is considered "UNSAFE" for entry. We must assume there is "Suspect Asbestos Containing Materials" that could not be collected for safety purposes.

**BASEMENT VIEW OF ABOVE FLOOR COLLAPSE**

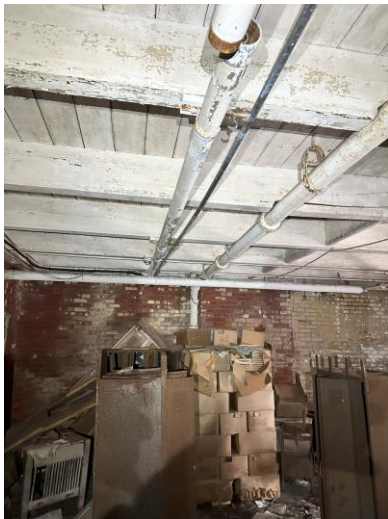
**H-A1**

Sample #	Location	Description	Color	% Asbestos	Quantities	Debris
H-A1	BASEMENT	PIPE INSULATION	WHITE	62%	500LF	4400SF
H-A2	BASEMENT	PIPE INSULATION	WHITE	62%	500LF	4400SF
H-A3	BASEMENT	PIPE INSULATION	WHITE	62%	500LF	4400SF
H-A6	BASEMENT 2 OVER 2 DOUBLE HUNG WINDOW	WINDOW GLAZING		2%	All windows 70 units as noted in H-A15	
H-A11B	IN REAR DINING ROOM/ROOM WITH SCALE	BACKING	GRAY	2%	1,300SF	
H-A13B	KITCHEN	BACKING	GRAY	TRACE	1,300SF	
H-A15	2 ND FLOOR EXTERIOR 2 OVER 2 DOUBLE HUNG WINDOW	WINDOW GLAZING	WHITE	2%	All windows 70 units	
H-A16	2 ND FLOOR INTERIOR ABOVE DOOR TO ROOM	WINDOW GLAZING	WHITE	2%	2,250LF All windows as noted in H-A15

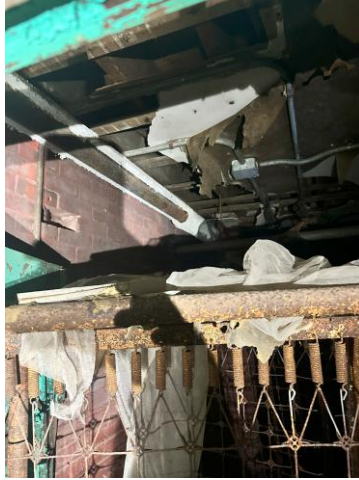
BASEMENT PIPE INSULATION

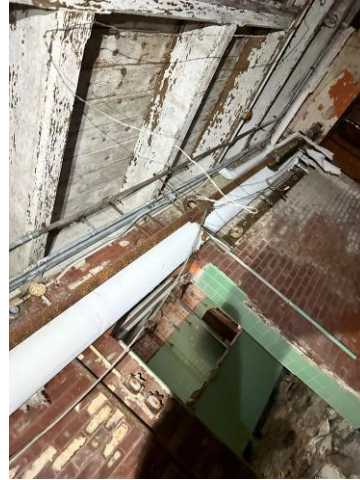
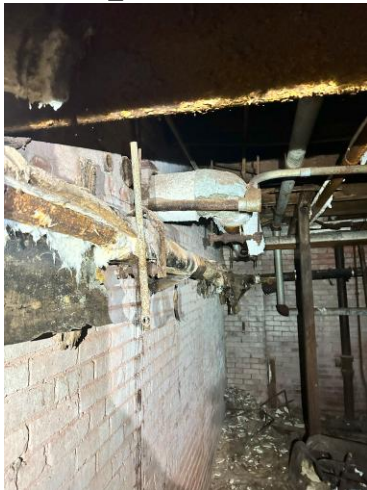
**BASEMENT PIPE
INSULATION**

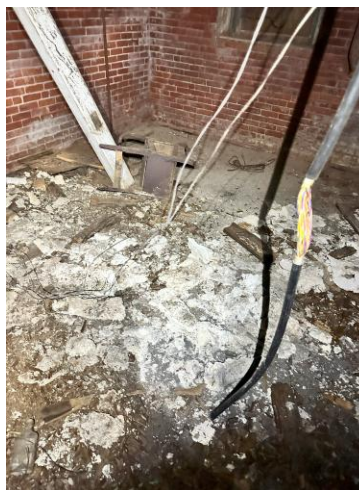
BASEMENT PIPE INSULATION DEBRIS

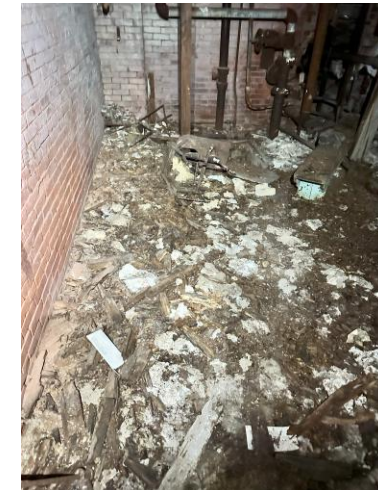
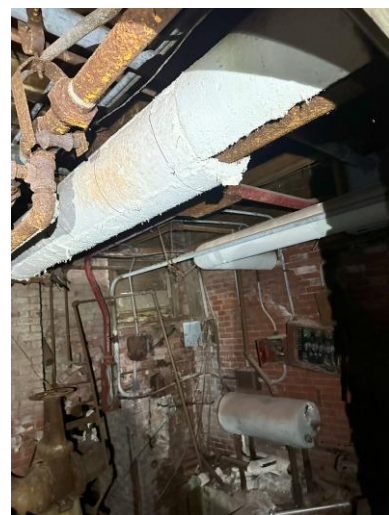
**BASEMENT PIPE
INSULATION AND DEBRIS**

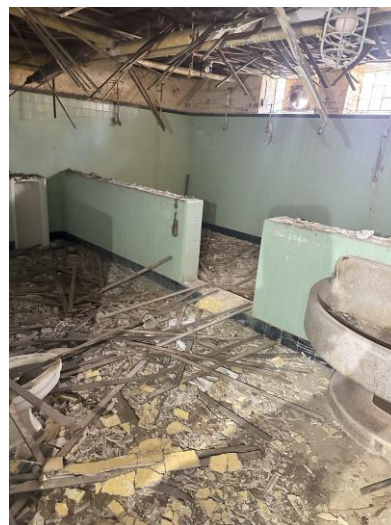
**BASEMENT BATHROOM
PLASTER PIPE INSULATION
THROUGHOUT**

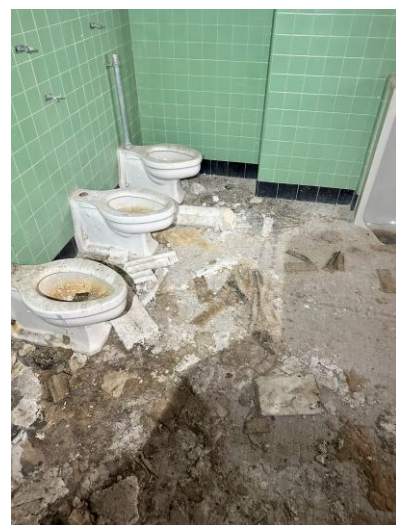
**PIPE DEBRIS IN BASEMENT
BATHROOM**

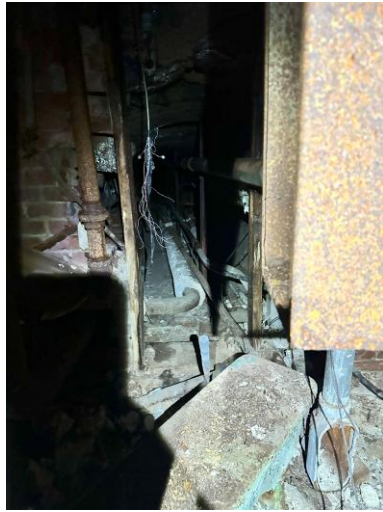
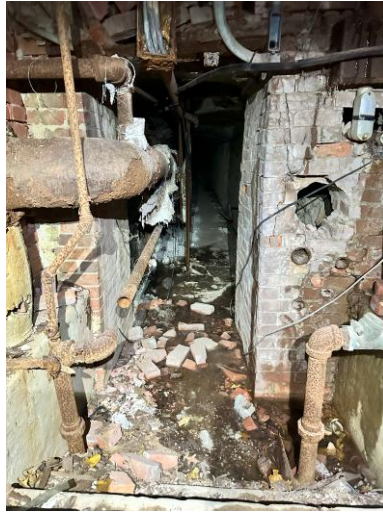
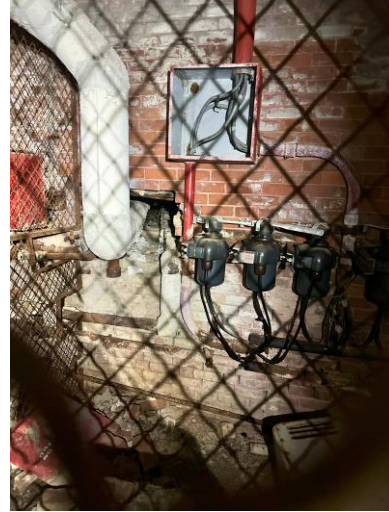
Additionally, there are three (3) underground steam tunnels exiting the “Hillside Building” which have also been deemed structurally unsound. TSI is observed extending into these tunnels from the basement of the building. This plan will outline the procedures to remove the TSI up to a safe distance from the entrance(s). At the conclusion of abatement activities, Mass Tech will hire a contractor to brick off the entrances to these tunnels.

ALL TUNNELS CONTAIN PIPE INSULATION AND PIPE INSULATION DEBRIS
