RFP 2026-GA-01

Project Design for Asbestos Abatement

75 North Dr.
Westborough MA. 01581

ASBESTOS SURVEY

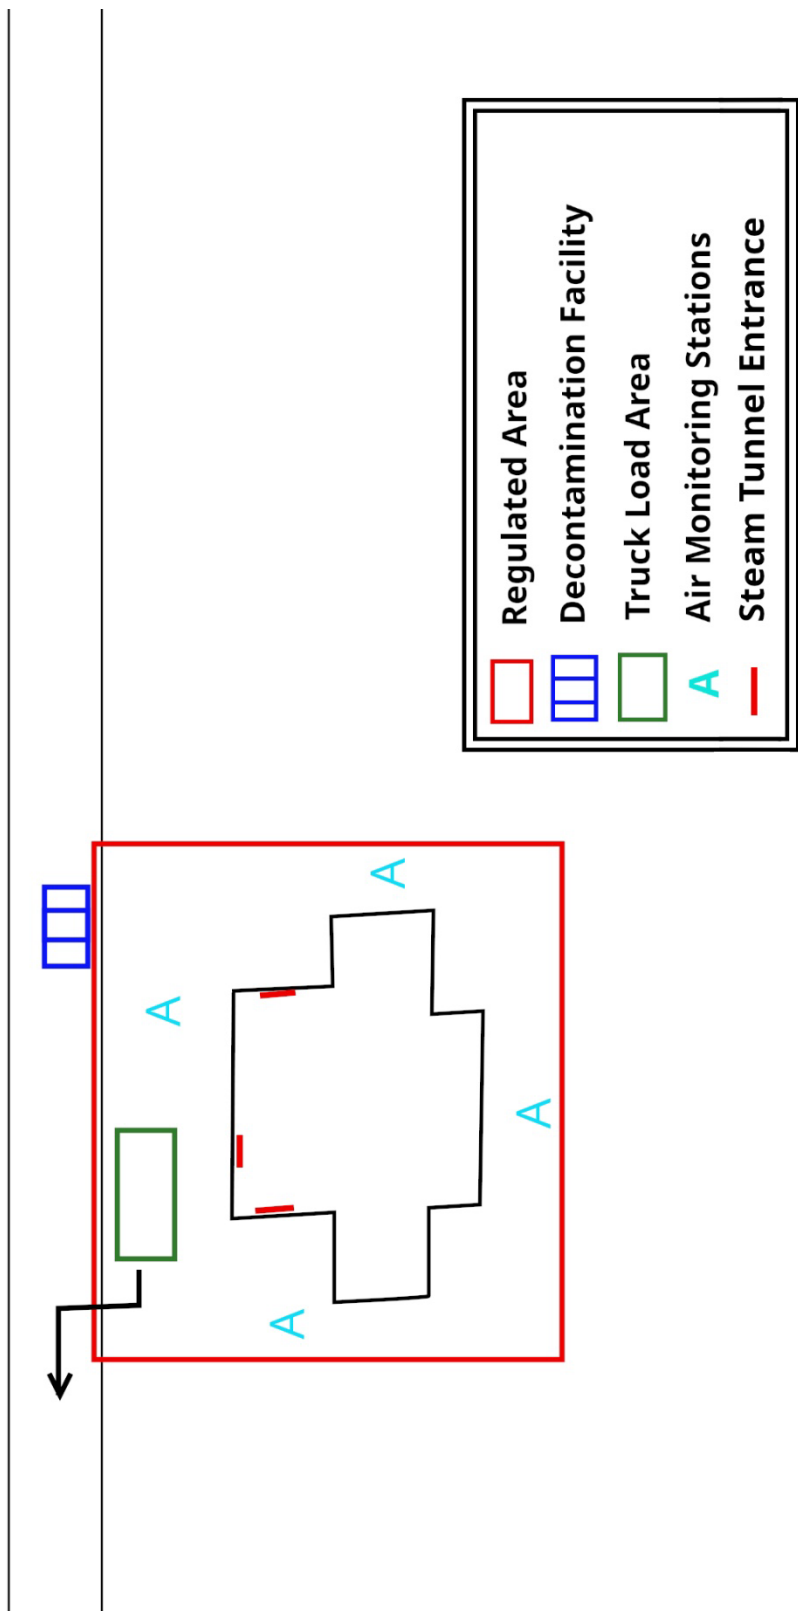
HillSide Building Site Map

Figure 2 depicts the location(s) of the wash/loading area. The wash/load area will be constructed following these guidelines:

1. A minimum of 20-mil rubber roofing membrane will be laid over the entire area of the heavy equipment decon station. The membrane will be adequately stabilized to prevent movement and rupture.
2. Hay bales will be placed around the perimeter of the heavy equipment decon station to denote the area and as a water collection barrier.
3. All decon water from the truck wash will be collected and passed through a 5-micron filter before being used to wet ACWM.
4. **Water runoff will not be allowed.**
5. Loaded waste trailers will not be allowed to remain onsite, overnight, in an uncovered state.

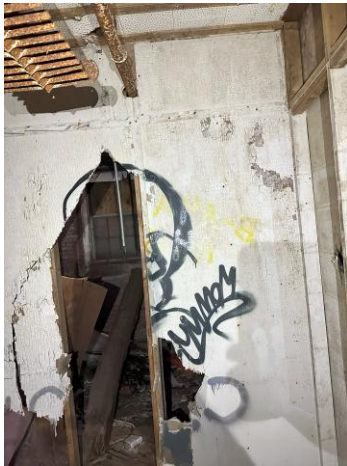
B-A4

Sample #	Location	Description	Color	% Asbestos	Quantities
B-A4b	Basement	Joint Compound	Off White	2%	3600+/- Sheetrock & Joint collapse. is in debris from collapse
B-A5	Basement	Boiler Insulation	Gray	75%	300SF as noted in B-A6
B-A7	Basement	Window Glazing	Beige	2%	All windows as noted in B-A8
B-A6	BASEMENT	BOILER INSULATION	Gray	75%	300SF +/-
B-A8	BASEMENT	WINDOW GLAING	BEIGE	2%	All windows. 75 Units
B-A12A	STAIRWELL BETWEEN 1 ST & 2 ND FLOOR ROOM	FLOOR TILE	BROWN	5%	145SF +/-
B-A13A	STAIRWELL BETWEEN 1 ST & 2 ND FLOOR ROOM	FLOOR TILE	BROWN	5%	145SF +/-

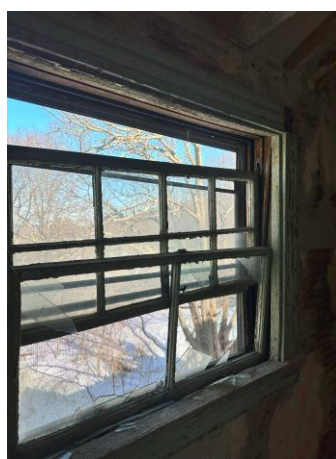
B-A16A	STAIRWELL BETWEEN 2 ND & 3 RD FLOOR ROOM	FLOOR TILE	BROWN	5%	145SF +/-
B-A17A	STAIRWELL BETWEEN 2 ND & 3 RD FLOOR ROOM	FLOOR TILE	BROWN	5%	145SF +/-
B-A18	3 RD FLOOR STAIRWELL 8 OVER 2 EXTERIOR WINDOW	WINDOW GLAZING	BEIGE	2%	All windows as noted in B-A8
	ROOFING MATERIALS			ASSUME POSITIVE	9000SF
	PIPE INSULATION			ASSUME POSITIVE	May be contained in walls

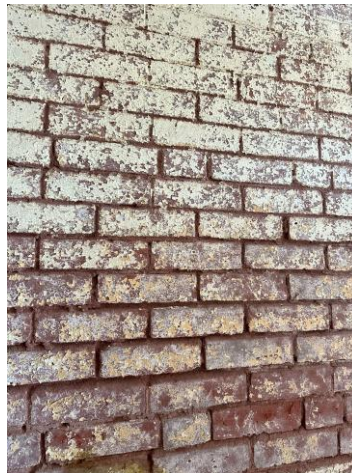
**B-L4**

B-L4	BASEMENT	5.95	FAIL
------	----------	------	------

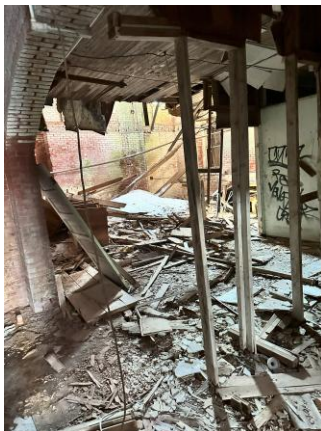
Interior of this building has 3 floors which has collapsed and is considered "UNSAFE" for entry. We must assume there is "Suspect Asbestos Containing Materials" that could not be collected for safety purposes.

**BASEMENT VIEW OF ABOVE FLOOR COLLAPSE**

NOTE: Given the advanced deterioration and decay, the use of traditional abatement methods has proven to be both unsafe and impractical for contractors tasked with the scope of work. We strongly recommend engaging a Certified Industrial hygienist/project designer to develop a non-traditional abatement plan to address necessary safety measures.

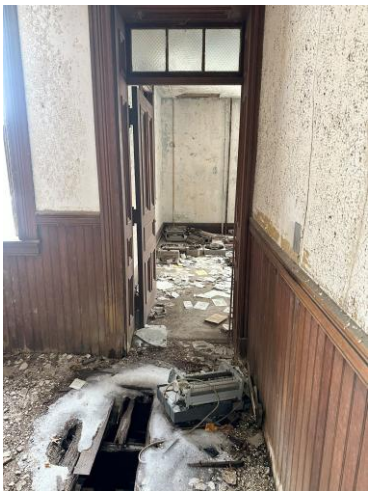
H-A16

H-A17	2 ND FLOOR INTERIOR ABOVE DOOR TO ROOM	WINDOW GLAZING	WHITE	2%	All windows as noted in H-A15	
H-A23	3 RD FLOOR 2 OVER 2 DOUBLE HUNG EXTERIOR WINDOW	WINDOW GLAZING	BROWN	2%	All windows as noted in H-A15	
	ROOF MATERIALS			ASSUME POSITIVE		
	TUNNEL PIPE INSULATION			ASSUME POSITIVE	2250LF	
	ALL PIPE INSULATION			ASSUME POSITIVE	May be contained in walls

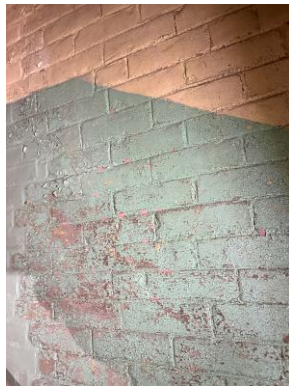
Sample #	Location	Result	Pass/Fail
H-L1	TOP FLOOR	3.315	FAIL
H-L2	2 ND FLOOR	8.367	FAIL
H-L3	1 ST FLOOR	3.204	FAIL
H-L4	BASEMENT	0.858	FAIL

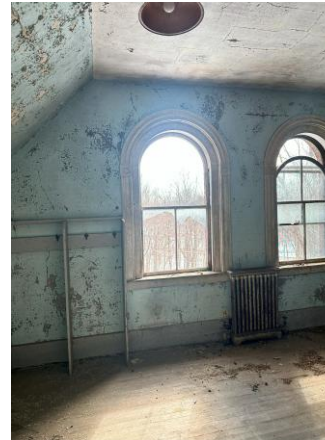
DOUBLE HUNG WINDOW				noted on O-A17	
	ROOF MATERIALS			ASSUME POSITIVE	5000SF	
	ALL PIPE INSULATION			ASSUME POSITIVE	Pipe may be contained in walls

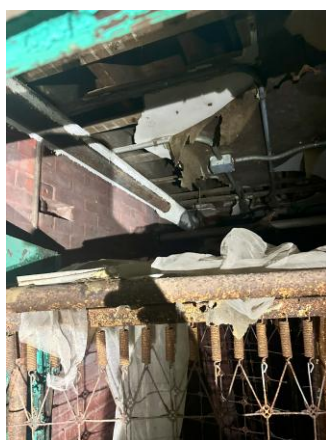
BASEMENT PIPE
INSULATION

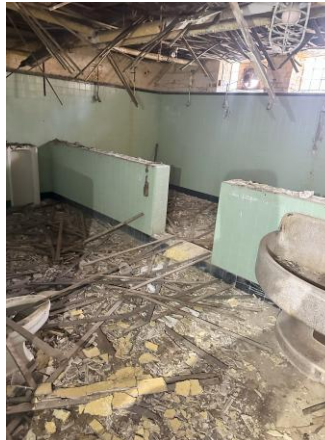
BASEMENT BATHROOM PLASTER
PIPE INSULATION THROUGHOUT
